Testing of Bearing Materials for Large Two-stroke Marine Diesel Engines

Klit, Peder; Persson, Sebastian; Vølund, Anders

12th EDF - Pprime Workshop: "Solutions for performance improvement and friction reduction of journal and thrust bearings"

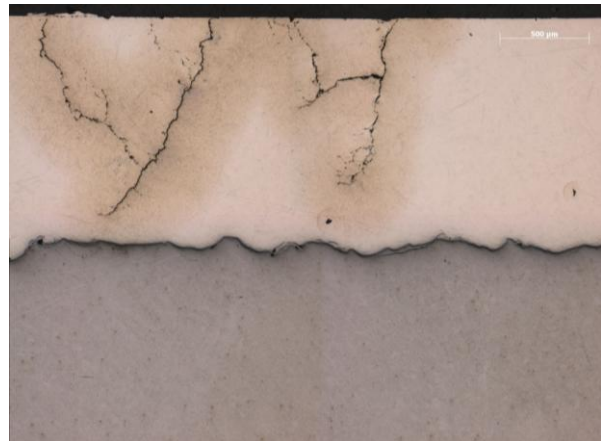
**Figure 21: Cross-section of Crack**

The cut out was grinded and further inspected in the microscope – see Figure 21. The picture shows the running surface as a line in the upper part of the picture, the white metal layer and the base material (steel). As shown in the picture it is obvious that some cracks (originating on the surface) are crossing each other below the surface thus making it possible for white metal particles of significant size to leave the disc. Furthermore it is observed that the cracks tend to change direction once the crack is getting closer to the steel interface. The examination clearly demonstrates the nature of the crack generation and propagation in white metal bearings. Furthermore it is concluded that the DFTR is capable of producing fatigue behaviour of white metal bearing alloys.
